## IV. Analysis and Evaluation

The analysis and evaluation of the cultural landscape for the Lincoln Memorial grounds are based on an examination of the historical records and the documentation of existing landscape resources in the study area. A summary discussion of the cultural landscape components documents landscape patterns, relationships, and individual features within a site, which define the character of the designed landscape. With this information, the overall significance and integrity of the landscape is addressed according to national register criteria for landscapes.

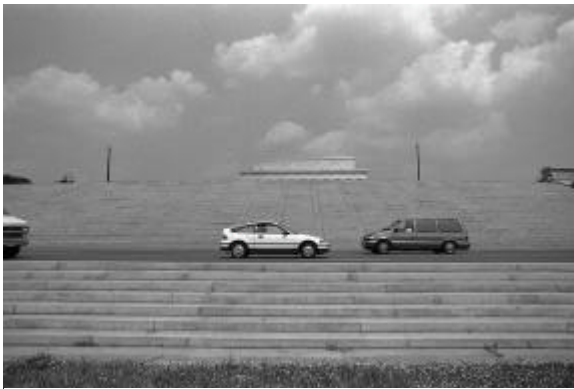
*Figure 114 - Granite Watergate steps, June 1996. LINC 9-12.*

sidewalks in the *Streetscape Manual* specify a granite curb and exposed aggregate concrete as the preferred material for all sidewalks within the Watergate area. These recommendations have been carried out. The color and texture of the new paving contrasts unfavorably with the granite material used for the wing walls, steps and bridge abutments. Only a few historic paving surfaces remain in use in the Watergate area, these include the granite block pavers at the base of the steps, as well as the granite steps themselves.

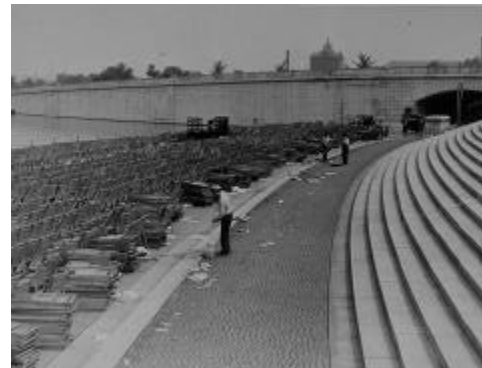
*Figure 115 - Granite block pavers at base of Watergate steps, c. 1939. MRC 1-5.*

**Paving Materials.** Originally, all the sidewalks were concrete and the bridle paths were soil base, with exception of the granite block pavers at the base of the Watergate steps. After 1950 when horse riding was deemed too dangerous in West Potomac Park, some of the bridle paths were paved with asphalt to create a stable base for pedestrian and bicycle traffic. No original concrete sidewalks remain in the area. Recommendations for

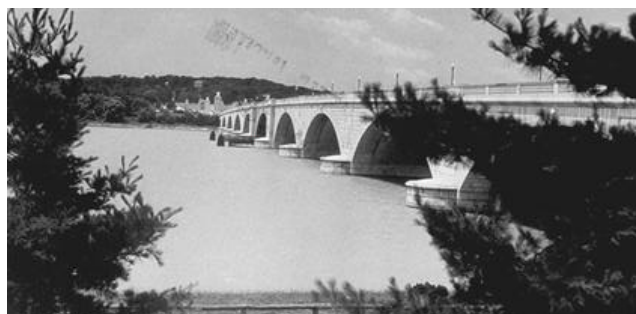
*Figure 116 - Rustic timber guardrail along Ohio Drive, c. 1935. MRC 1-70.*

Barriers are utilized on some of the vehicular routes as well. Wooden traffic barriers and cones are used during rush hour to control one-way traffic on Rock Creek and Potomac Parkway. This practice has been in effect since 1937. In addition to the daily “temporary” barriers, there were rustic guardrails placed along Ohio Drive after its completion in 1933.
